EUROPEAN PATENT APPLICATION

(54) Method for repairing an apertured gas turbine component

(57) A method is disclosed for repairing defects in a gas turbine component 10 that comprises a substrate 58 and an existing coating 44 on the substrate 58. The article 10 includes cooling holes 18 having a predetermined air flow requirement and an outer shaped portion 52 and an inner metering portion 60. The method comprises removing the existing coating 44 and recoating the surface of the article with a nonoriginal coating. After

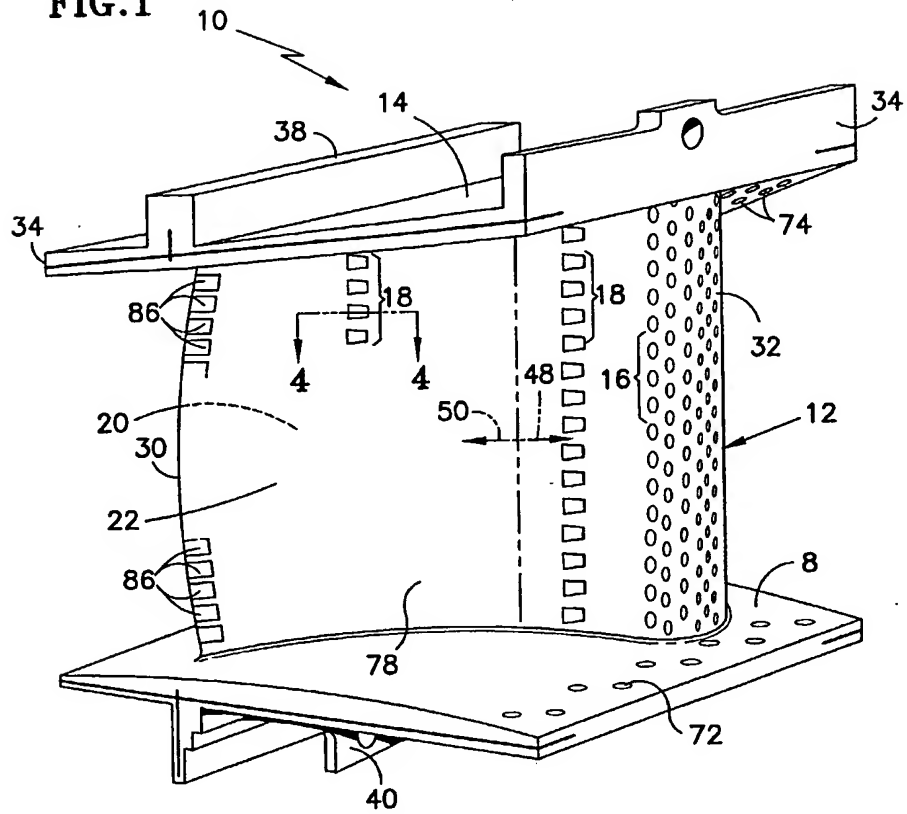
FIG.1

Fig. 1 is a perspective view of a typical gas turbine engine high pressure turbine vane;

[0025] Referring to Fig. 1, a high pressure turbine vane (article) 10 is shown. Referring also to Figs. 2 and 3, a top view and a bottom view are respectively shown for the vane 10 of Fig. 1. The vane 10 comprises an airfoil section (airfoil) 12 having at least one internal cavity 24 (Fig. 2), the internal cavity 24 having an internal surface 26 (Fig. 2). The airfoil section 12 has a convex surface 20 and a concave surface 22. The convex and concave surfaces 20, 22, respectively, are bounded by a trailing edge 30 and a leading edge 32 and together form an exterior surface 78 of the airfoil. The exterior surface 78 is exposed to the hot gas path. The trailing edge 30 of the airfoil 12 includes cooling slots 86. Also, the airfoil section 12 is bounded by an inner diameter platform (platform) 8 and an outer diameter platform (platform) 14. The inner and outer diameter platforms 8, 14 create the gas path annulus and include cooling holes 72, 74, respectively. The outer diameter platform 14 includes opposing flanges 34, at least one cover 36 (Fig. 2), preferably two, and a rail 38. The inner diameter platform 8 includes a rail 40 and a cover 42 (Fig. 3), preferably two.

[0027] The vane 10 lies in the hot gas path and the vane 10 is air-cooled by flowing cooling air, typically from the compressor discharge, into the internal cavities 24. Cooling air enters the internal cavities 24 through corresponding openings in the platforms 8, 14. This air cools the internal surface 26 of the airfoil 12 by convection or internal baffle impingement and cools the convex and concave surfaces 20, 22, respectively, of the airfoil 12 by film cooling. The air is directed from the internal cavities 24 and outward across the vane 10 by a plurality of cooling holes, preferably cylindrical cooling holes 16 and diffusion cooling holes (diffusion holes) 18, to help it withstand the high temperatures to which it is exposed. The cooling air is also directed across the platforms 8, 14 upon exiting the respective cooling holes 72, 74. The trailing edge 30 is cooled by air exiting through the slots 86.

[0028] Although Fig. 1 shows the plurality of cooling holes 16, 18 located on the concave surface 22, it is readily understood by those skilled in the art that the plurality of cooling holes 16, 18 are formed on both the convex and concave surfaces 20, 22, respectively.

[0031] Referring now to Figs. 1 and 4, it is noted that the vane 10 has a plurality of diffusion holes 18 which may have various geometries and predetermined air flow characteristics based on location within the vane 10. The representative diffusion hole 18, shown in Fig. 4, has a metering passage 60 in fluid communication with a diffusion passage (mouth) 52, each having a predetermined geometry. The metering passage 60 has an inlet 76 with a predetermined throat area, shown as A_t , where the throat area A_t provides a predetermined air flow requirement. Thus, the inlet 76 regulates cooling air flow into the diffusion holes 18 from the internal cavities 24. The diffusion passage 52 is axially diverging, nonregulatory and extends from the inlet 76 to an outlet 77 at the exterior surface 78 of the vane 10. The diffusion passage 52 facilitates the film cooling of the exterior surface 78 of the airfoil 12 as the cooling air exits from the diffusion passage 52 of the diffusion hole 18. The diffusion passage 52 also includes an inner shaped portion (inner diffuser portion) 80 while the metering passage 60 includes an inner metering portion 82.

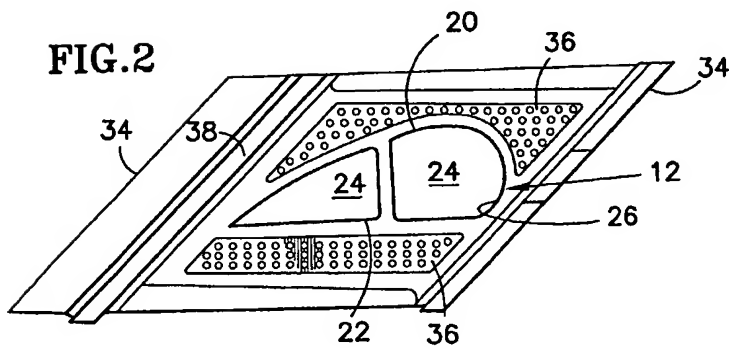
FIG.2

Fig. 2 is a top view of the vane of Fig. 1;

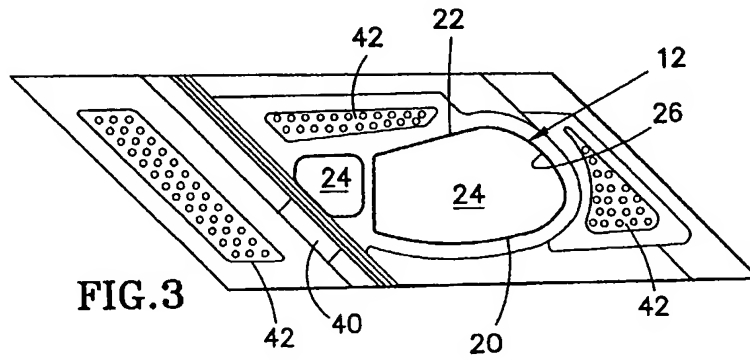
FIG.3

Fig. 3 is a bottom view of the vane of Fig. 1;

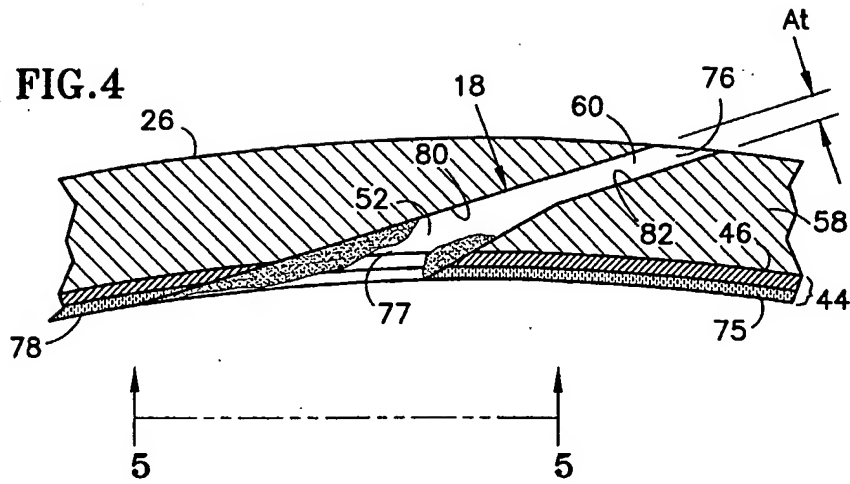
FIG.4

Fig. 4 is an enlarged cross-sectional view taken essentially in the direction 4-4 of Fig. 1 and illustrating the vane substrate, an existing protective coating applied to the substrate and a typical diffusion cooling hole extending through the substrate and the coating;

[0029] Referring to Fig. 4, a cross-sectional view of the wall thickness of the airfoil 12, and in particular the diffusion hole 18, is shown taken along the line 4-4 of

[0030] To further protect the vane 10 (Fig. 1) from high temperatures, the airfoil 12 and the platforms 8, 14 are coated with a protective surface coating, preferably a thermal barrier coating (TBC) system. The thermal barrier coating system 44 comprises a metallic bond coat 46 disposed over a substrate 58 of the vane 10 (Fig. 1), and a ceramic top coat 75 on top of the bond coat 46.

[0048] Referring now to Figs. 1, 4 and 5, diffusion holes 18 located in region 50 may require reworking. The application of the nonoriginal metallic bond coat 46 to the entire surface 78 of the vane 10 may result in a quantity of excess bond coating accumulating in the diffusion passage 52 of the diffusion holes 18 thus reducing the area through which the cooling air passes. Since this "coatdown" phenomena, as shown in Figs. 4 and 5, affects most, if not all of the diffusion holes 18 in region 50, the effectiveness of the cooling medium is diminished and the vane's durability is compromised. The coatdown phenomenon is normally not a problem during the manufacture of original equipment vanes since the protective coatings, and in particular, the metallic bond coat, are usually applied prior to installation of the cooling holes.

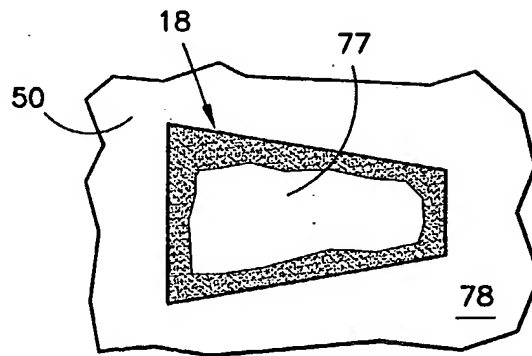
FIG.5

Fig. 5 is a view taken essentially in the direction 5-5 of Fig. 4 showing the diffusion hole prior to the repair of the present invention;

Fig. 1. Fig. 5 shows a view taken essentially in the direction 5-5 of Fig. 4 showing the diffusion hole 18 prior to the repair of the present invention.

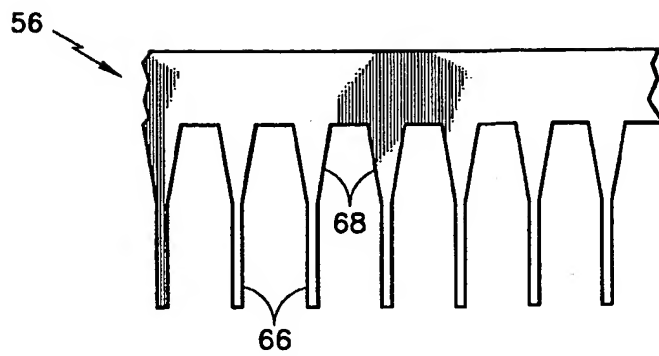
FIG.6

Fig. 6 is a side view of an electrode suitable for use with the repair method of the present invention; and

[0051] Referring to Figs. 6 and 7, electrodes 56, 62 suitable for insertion into an electric discharge machining device are shown. Referring to Figs. 1, 4, 5 and 6, the remanufacture and repair of the diffusion holes 18 in local regions 48, 50 of vane 10 using electrodes 56, 62, respectively, will now be described.

[0052] The electrode 56 includes a metering portion 66 and a diffuser portion 68. The electrode 62 includes a diffuser portion 70. It is noted that the geometry of the individual electrodes 56, 62, specifically the respective portions 66, 68, 70, are preselected to correspond to the required shape of the corresponding diffusion hole 18 to which it is used. In particular, the electrode 56 is chosen to restore the inner diffuser portion 80 and inner me-

[0054] In local region 48, the diffusion hole 18 is now remanufactured using the electrode 56. Since the repair material filled the diffusion hole 18, both the metering portion 66 and diffuser portion 68 of the electrode 56 are required to effect the remanufacture. The diffuser portion 68 of the electrode 56 corresponds in shape to the diffuser passage 52, and more specifically, the inner diffuser portion 80, of the diffusion hole 18. While, the metering portion 66 of the electrode 56 corresponds to the metering passage 60, and more specifically, the inner metering portion 82 of the diffusion hole 18.

[0055] However, in local region 50, the diffusion holes 18 may be partially or fully clogged, as described earlier, and therefore will need to be reworked to restore the cooling effectiveness of the diffusion hole 18 as well as vane durability. This is accomplished by using the electrode 62 to remove the excessive bond coat material. The electrode 62 may be easily formed by removing a metering portion from an electrode that has a diffuser portion corresponding in shape to the diffuser passage 52, and more specifically, the inner diffuser portion 80, of the diffusion hole 18. This can be accomplished by using a cutting means, for example scissors, to remove the metering portion.
